# Learning from Disaster: Bayland Marina Recovers from Hurricane Ike

By Robert Wilkes

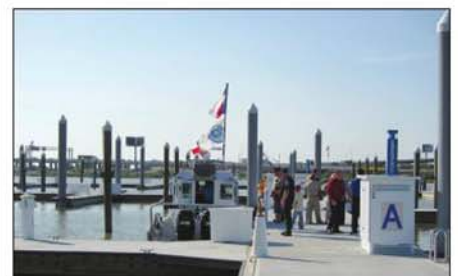
The new configuration at Bayland Marina is more wave resistant and provides easier access in and out of the marina.

Bayland solicited suggestions from slip tenants during the design phase. Wise lives in Houston and enjoys sailing. He knew firsthand that the prevailing winds in the marina were often on the beam. “A 15-degree change in slip orientation made a difference,” Wise said. “The winds are more down the bow.”

In addition, the design reserves space to expand the number of slips at a later date. Bellingham Marine provided all new floats with 20-inch freeboard, two inches more than the floats it replaced. The new marina has state-of-the-art utilities and beefed up timber walers.

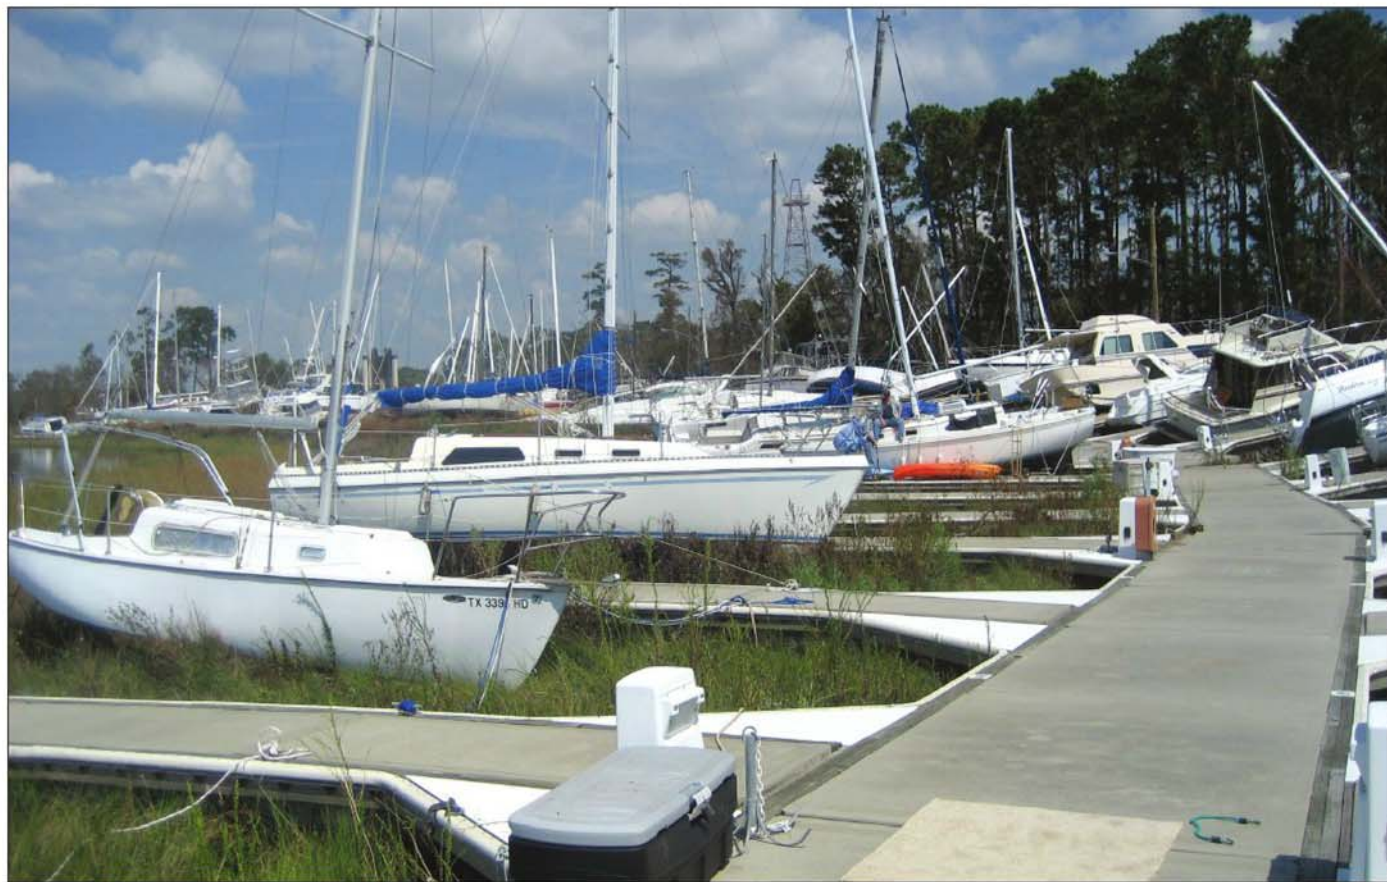
Wind pressure on the boat hulls created enormous forces that were transmitted through the cleats to the docks and then the pilings. As the surge crested the marina's breakwater, it lifted the docks and boats to the tops of the pilings. This is the ultimate test of the strength of the pilings because the full force of the hurricane is at the greatest distance from the fulcrum point at the bottom of the bay. With a few exceptions, most of the pilings held. As the surge overtopped the pilings, whole sections of the marina, docks and boats together, washed ashore. A line of large pine trees prevented the docks and 87 boats from going further inland. Most of the boats were still tied to the docks when the storm receded.

*When Hurricane Ike hit Bayland Marina in Baytown, Texas, the marina was lifted above the pilings and floated inland until it was stopped by the tree line. The cleanup began six weeks after the storm, and six months before the last boat was craned into the water.*

The pileup resembled a game of pick-up-sticks. "It was the boat owner's responsibility to get his boat back in the water," Johnson said, "but with the tangle of boats and the legal, insurance and safety factors involved, we insisted on a methodical process. The cleanup took six months. The hurricane hit in September, and the last boat was lifted back into the water in March."
